Update on Construction and temporary closure of the Salesforce Transit Center

November 2018

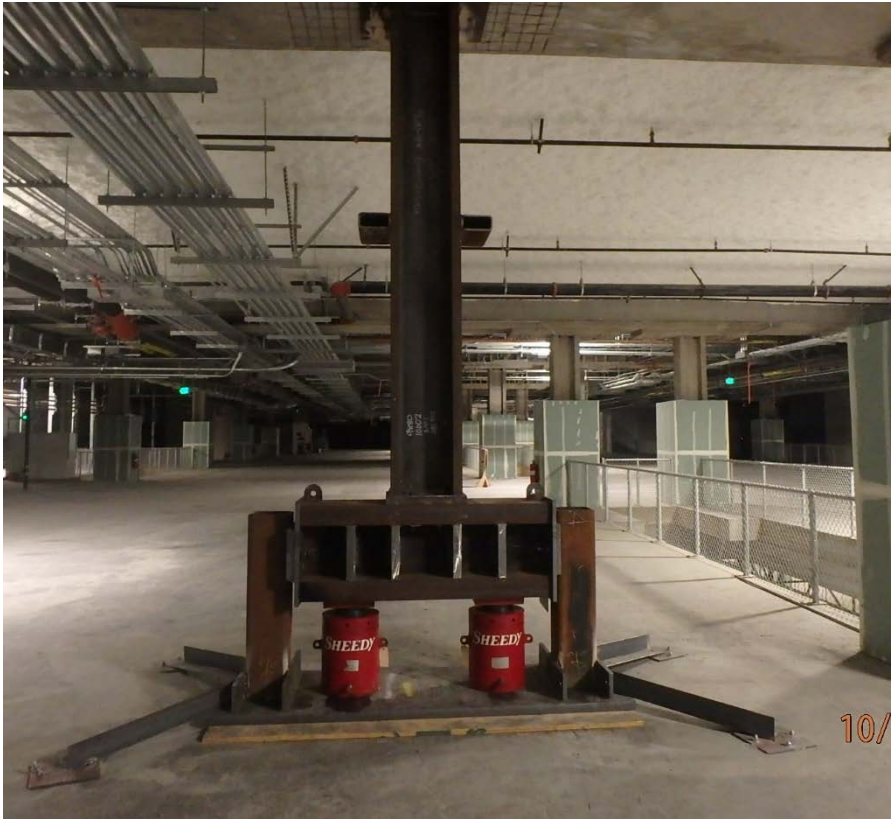
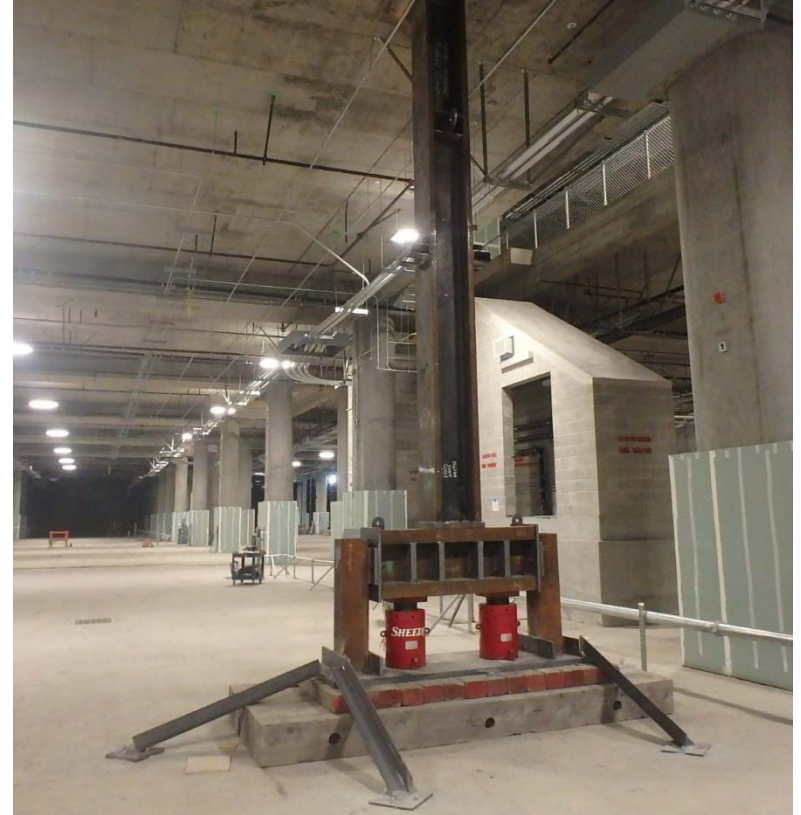
Fremont Street Temporary Support Phase 2 (Trainbox Levels)

Lower Concourse level

Train Platform level

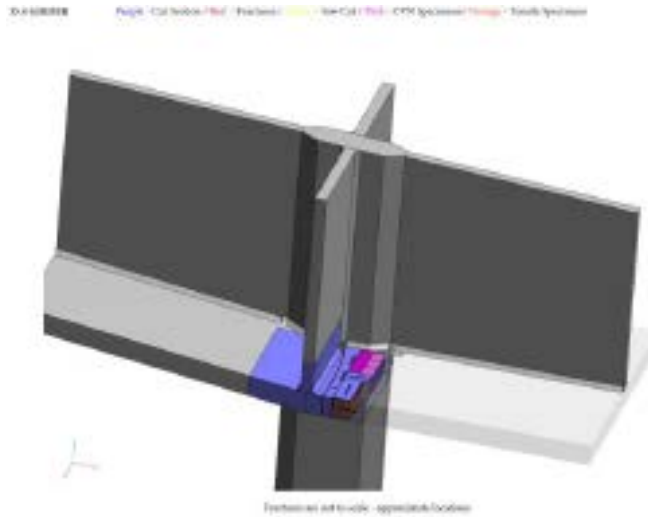
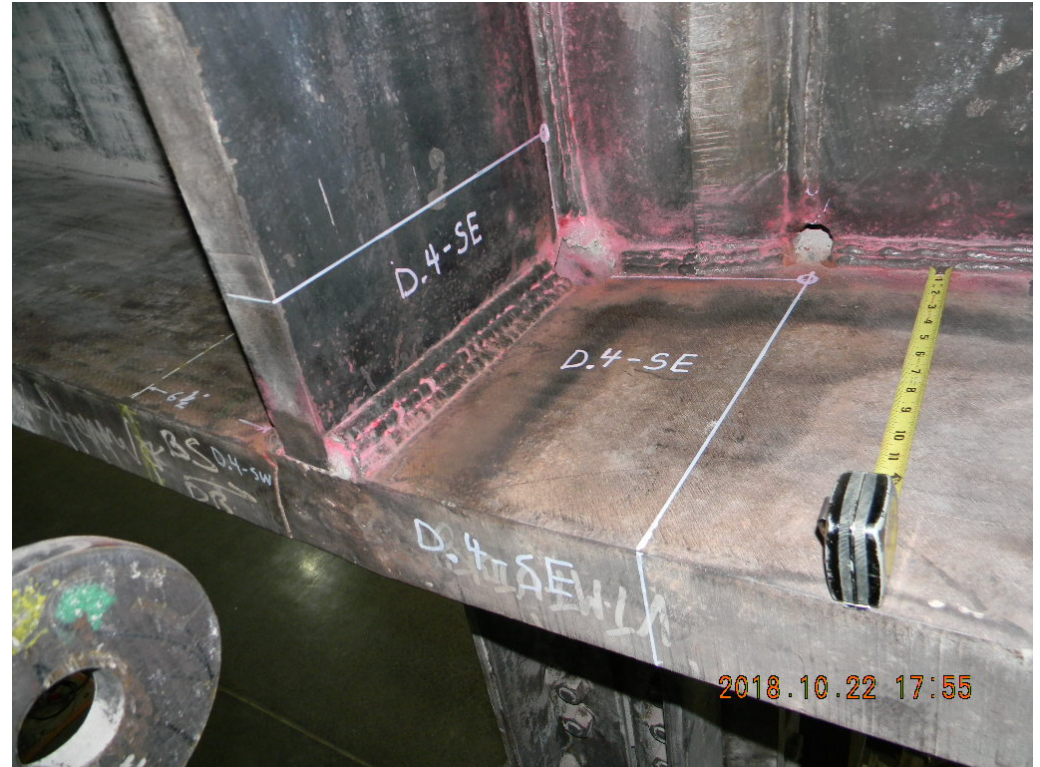
Fremont Street Phase 3 Sampling (Bus Deck Level)

Samples being removed by 'In Place Machines/Cutting Edge of Wisconsin' by a wire saw (mutually agreed by Peer Review Panel & project experts),

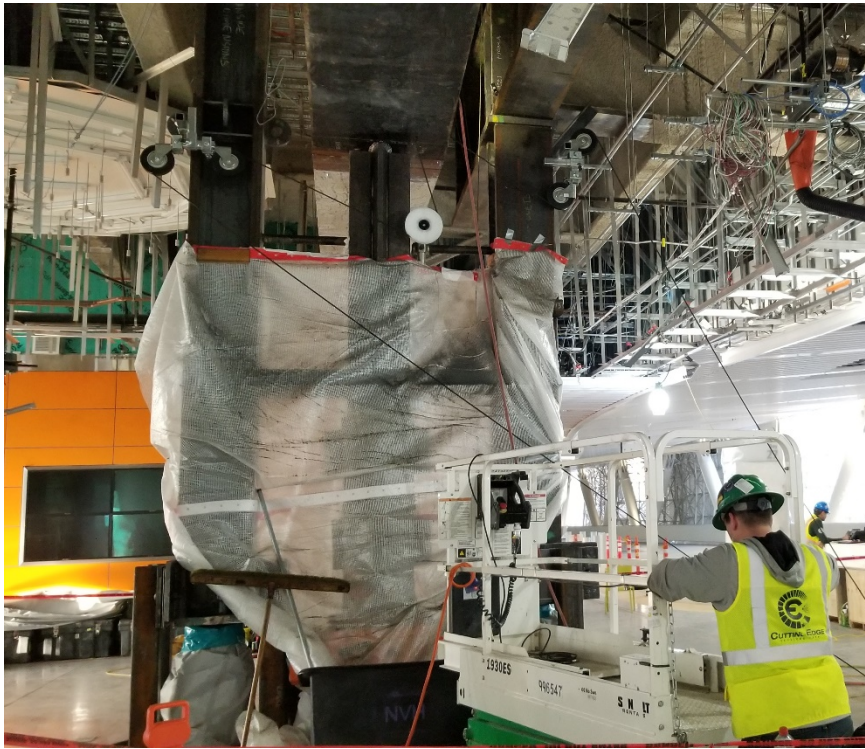
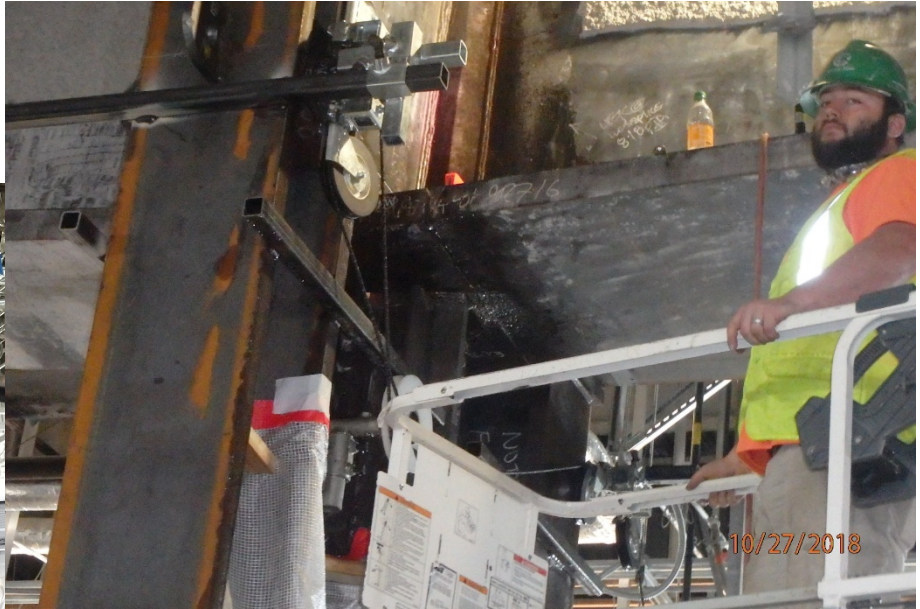
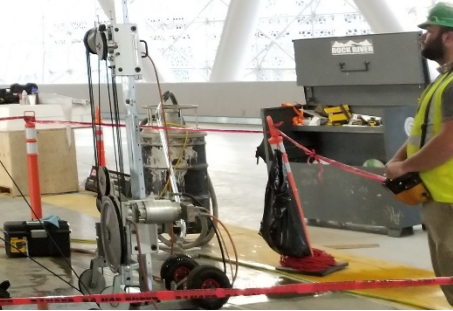
Fremont Street Phase 3 Sampling (Bus Deck Level)

Samples removed by In Place Machines/Cutting Edge of Wisconsin by a wire saw
(mutually agreed by Peer Review Panel & project experts)

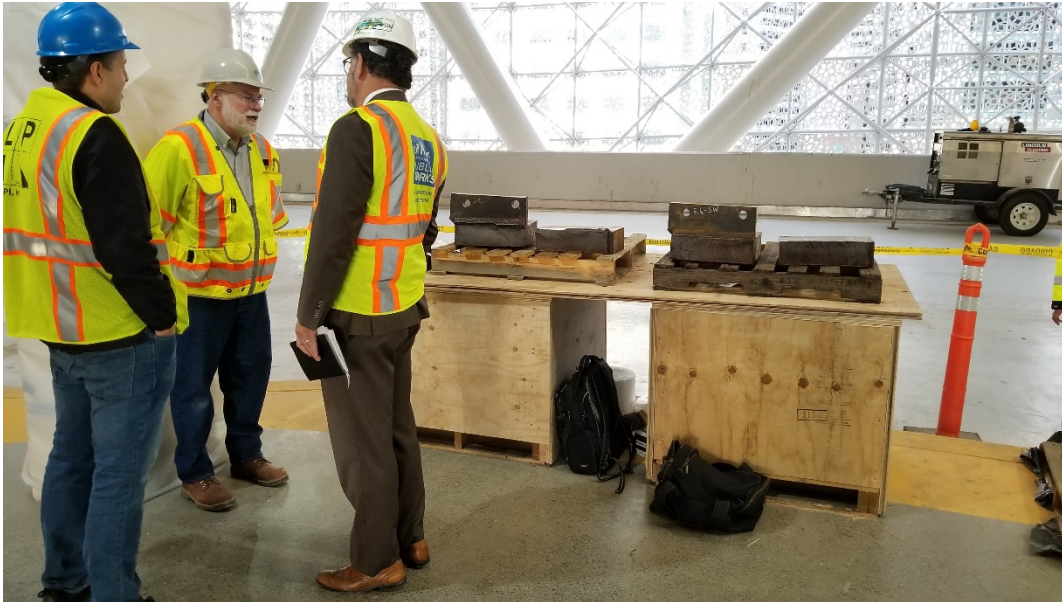
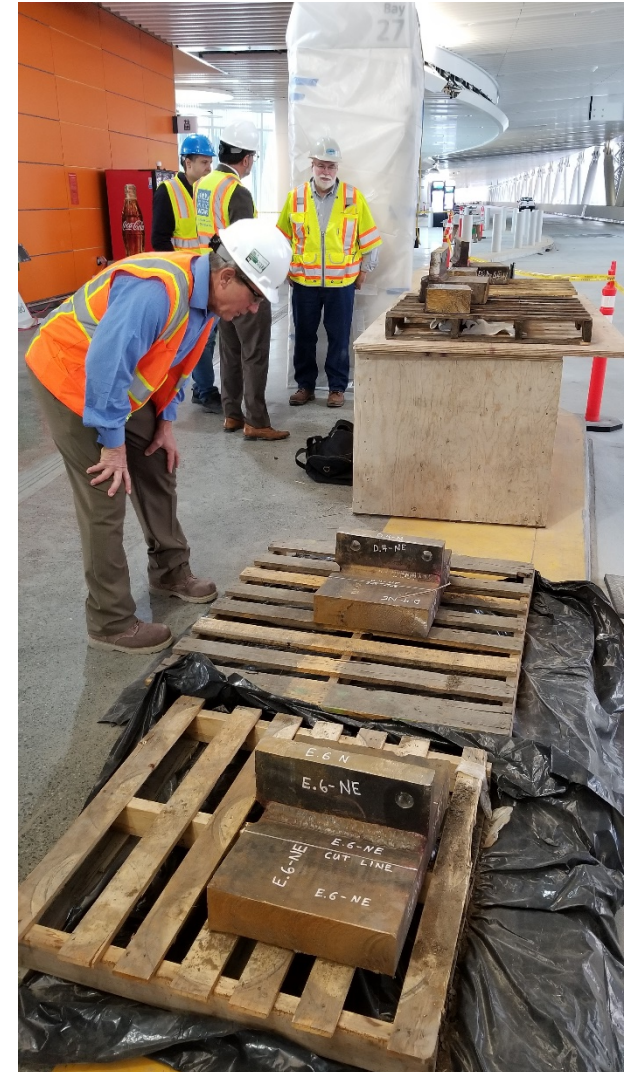
Fremont Street Phase 3 Sampling Coupons/Expert Review

Samples are being tested by LPI labs of New York (mutually agreed by Peer Review Panel & project experts)

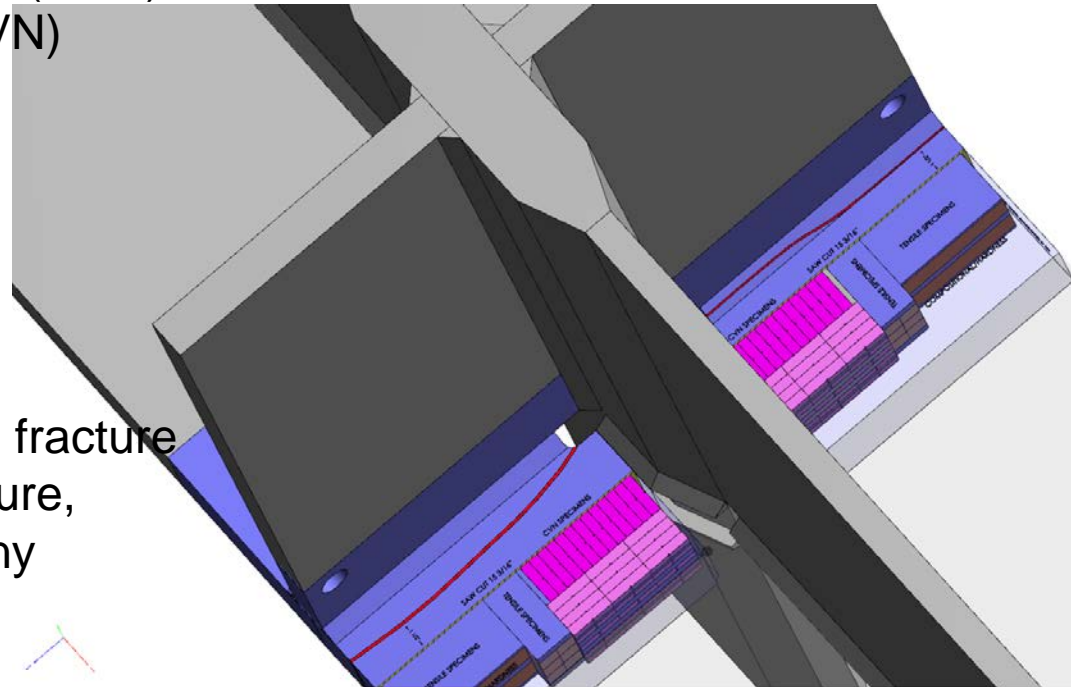
Fremont Street Phase 3 Testing

Tests being performed with Peer Review

Panel Approval:

- Scanning Electronic Microscopy (SEM)
- Charpy V Notch Toughness (CVN)
- Rockwell Hardness Test (HRC)
- Tensile Test
 - Dual Tensile
 - Quarter Tees
- Fractographic analysis
- Metallographic Analysis
- Stereographic Evaluation of the fracture surfaces noting node(s) of fracture, origin and relevant defects, if any
- Macrostructure Examination
- Microstructure Examination

Fractures are not to scale - approximate locations

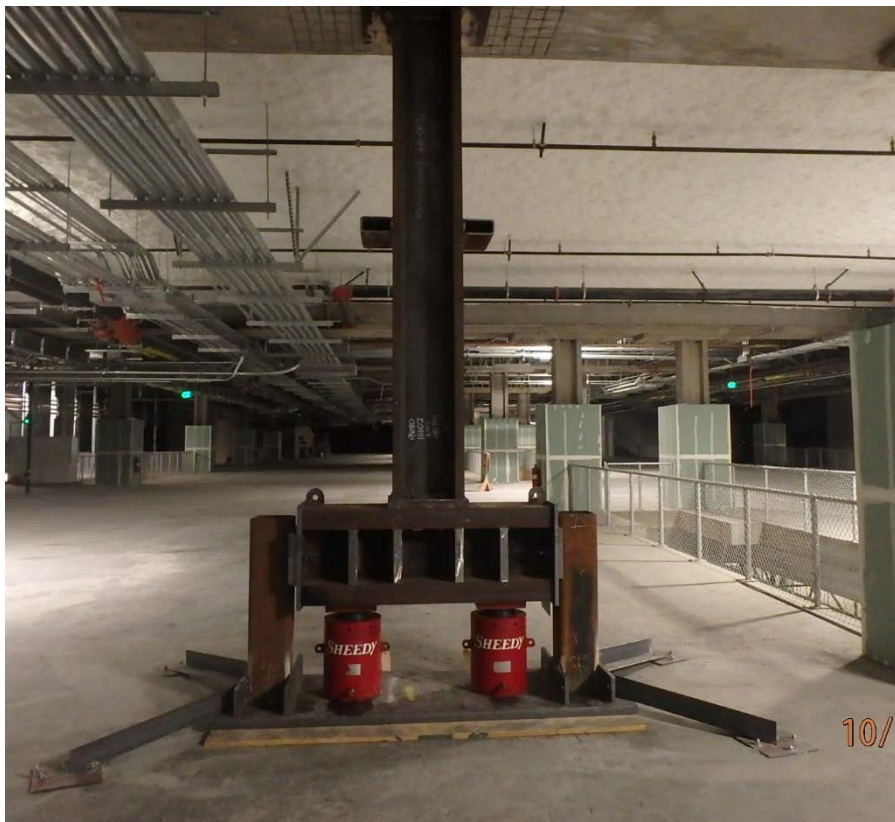
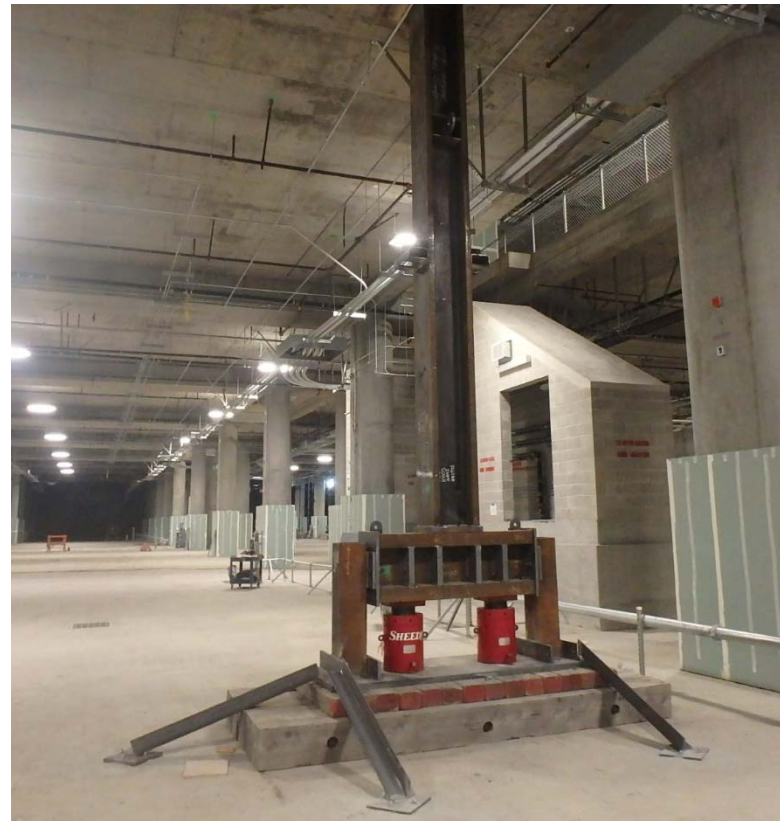
First Street Temporary Support (Trainbox levels)

Lower Concourse level

Train Platform level

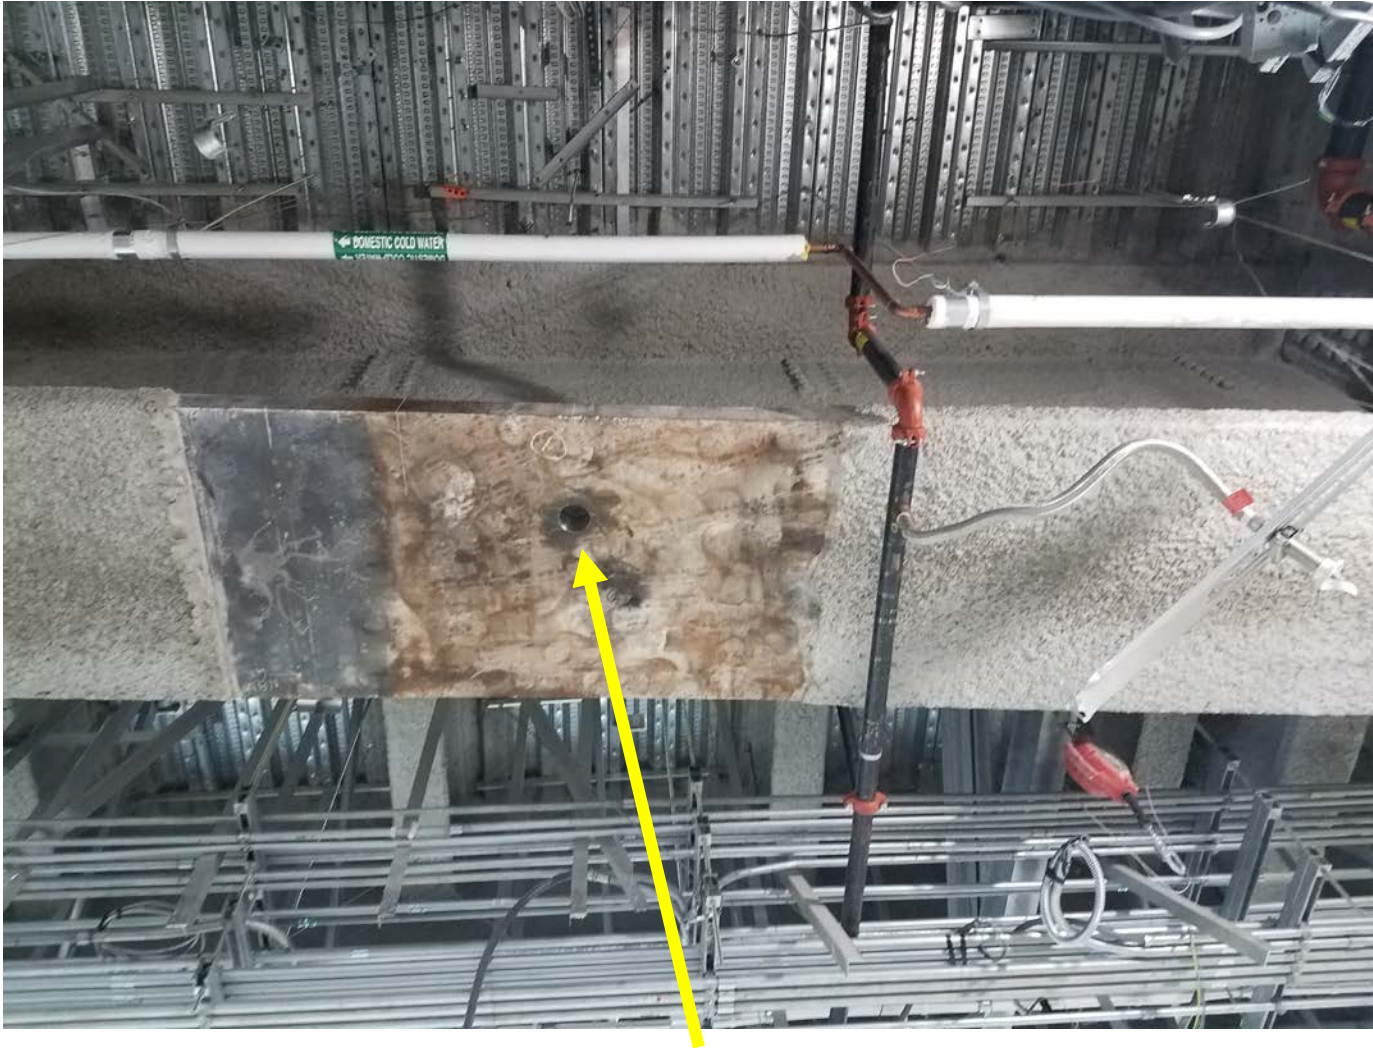
First Street Testing

Core sample taken to advance testing process
